ACM Home Inspection

Home Inspection Report

Date of Inspection: 6/2/2021 Time: 4:00
Age of Home: 38 years Size: 1,577 sqft

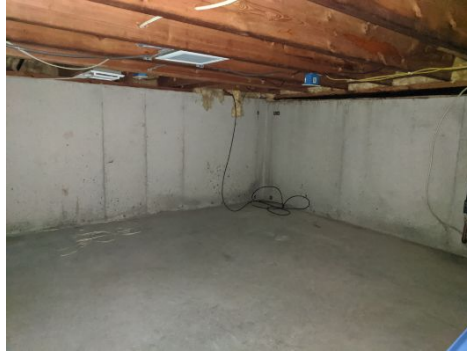
crawl space foundation walls appeared serviceable

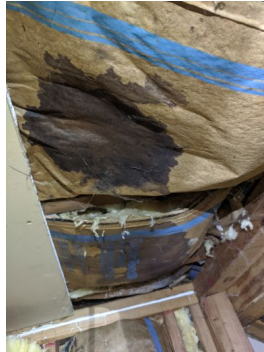
Page 4	Crawlspace	• Repair: Noted moisture on insulation under stairs and on sheet rock. There was signs of microbial growth on the other side of this wall in the garage. Recommend remediation by a licensed professional. The moisture may be coming in from the full gutter above this area.
--------	------------	--

- Repair: Noted moisture on insulation under stairs and on sheet rock. There was signs of microbial growth on the other side of this wall in the garage. Recommend remediation by a licensed professional. The moisture may be coming in from the full gutter above this area.

insulation in the crawl space under the stairs is moist

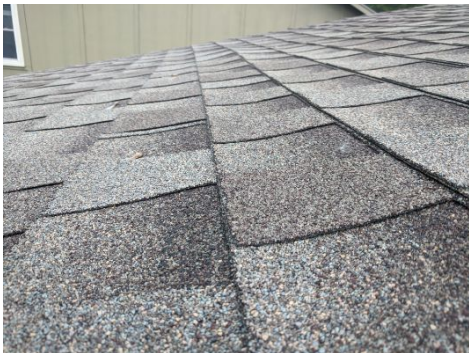
- Monitor: Noted raised and soft areas of subroof under the shingles. Recommend to monitor for moisture build up and repair if any gaps are observed in the roofing.

Raised section of sub roof

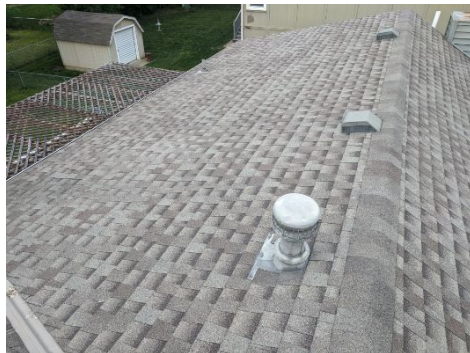
roof covering in good condition

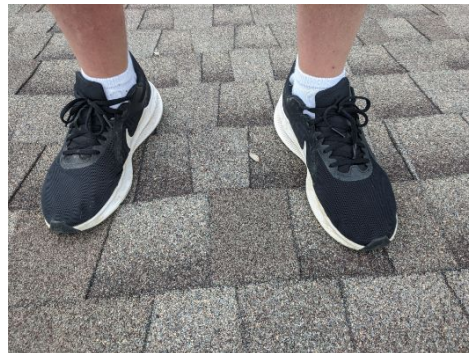
soft spot in the subroof

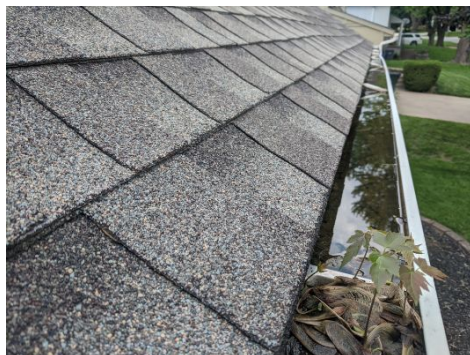
- Repair: The gutters require cleaning to avoid spilling roof runoff around the building - a potential source of water entry or water damage to the structure. Evidence of excessive moisture/microbial growth in the crawl space and garage may be caused by water intrusion from the gutters.

The front gutter was restricted and full of water

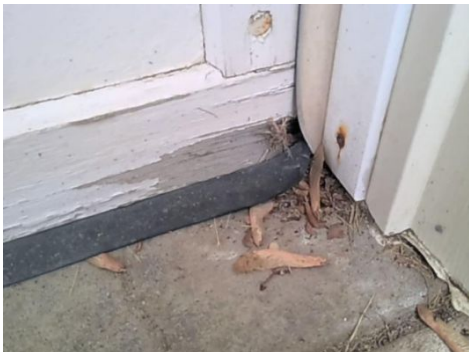
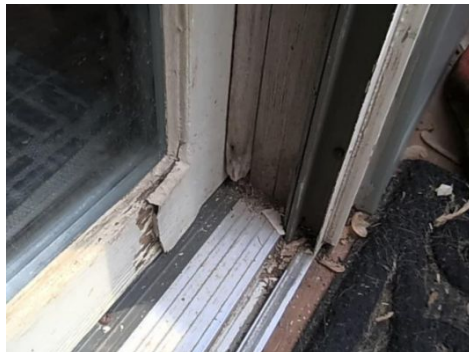
- Repair: Noted handle on the front screen door misaligned with interior handle. Chipped and peeling paint on garage doors. On the rear slider the door was damaged and trim was not painted. Repair is recommended.

damage to rear slider, exposed wood frame

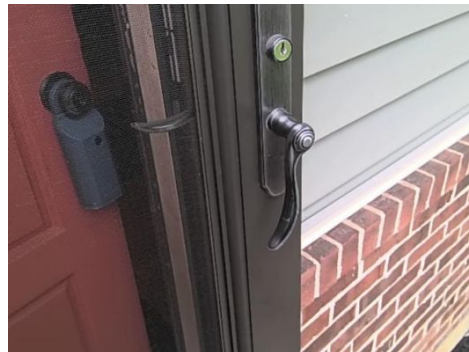
screen door handle down

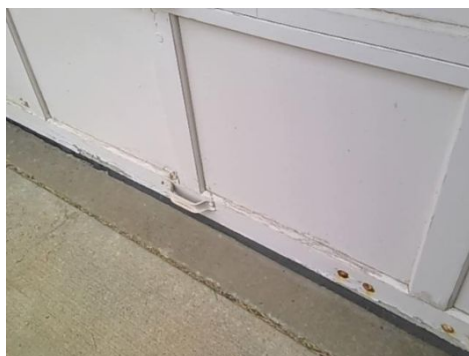
garage door peeling paint and corrosion

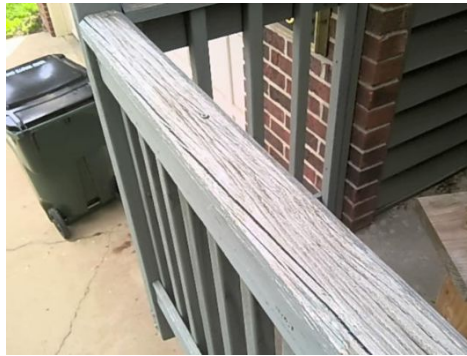
- Repair: Noted worn and peeling paint on hand rails. Recommend coating to prolong life.

peeling paint

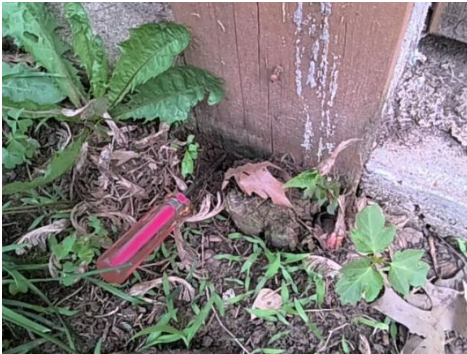
- Repair: Noted areas of wood rot on deck posts and some splitting of wood. There were several areas where paint was faded or bare. Recommend repair/replacement of rotten wood as necessary posts should rest on concrete and deck should be coated.

wood rot on posts in contact with soil

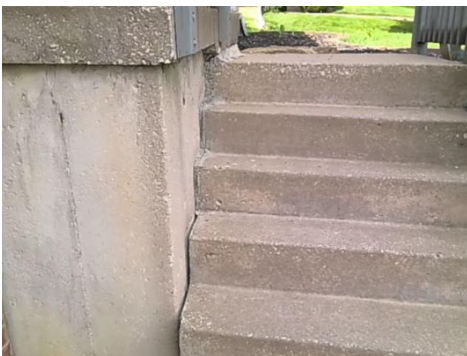
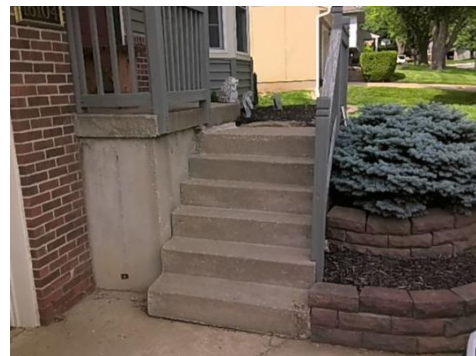
- Repair: Noted settlement of front stairs/ walkway, creating a trip hazard. Recommend adding sand/dirt beneath stones to level surface.

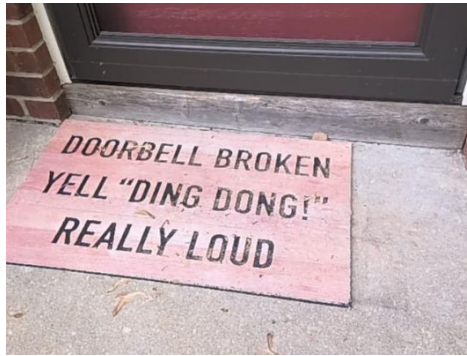
- Repair: Front door bell appeared to work intermittently.

doorbell doesn't work bare wood

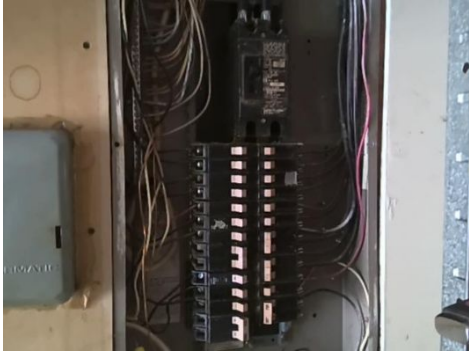
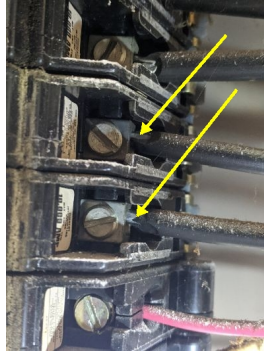
- Safety Issue: Observed aluminum branch wiring in the main electric panel (dryer circuit). Recommend that a licensed electrician evaluate before closing.

appeared to be solid core
aluminum on dryer circuit

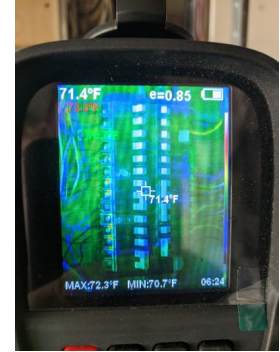
thermal ok

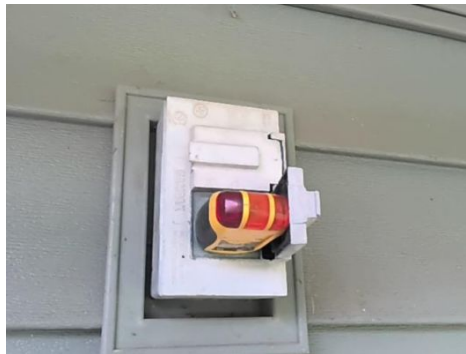
- Repair: Noted an inoperative outlet upper exterior receptacles. Recommend conferring with owner to see if there is a switch or repair/replace.

front exterior doesnt work

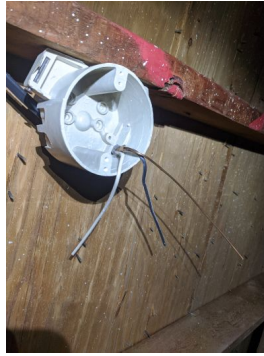
- Repair: Noted improperly terminated wiring in that attic. Recommend properly terminating wires.

improperly terminated wiring in the attic

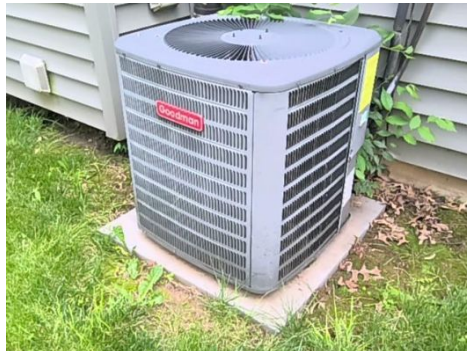
goodman 2012 r 410

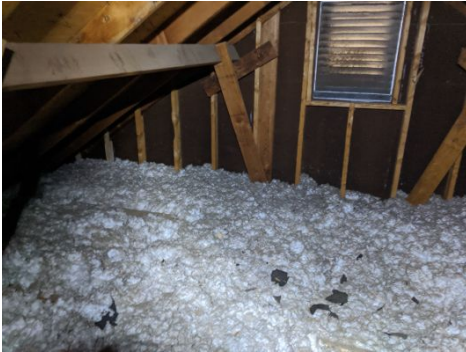
insulation near r25

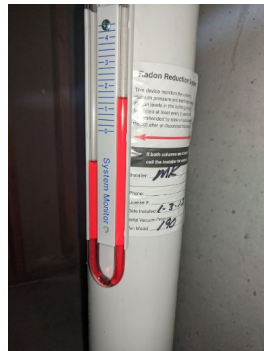
appeared to be operating

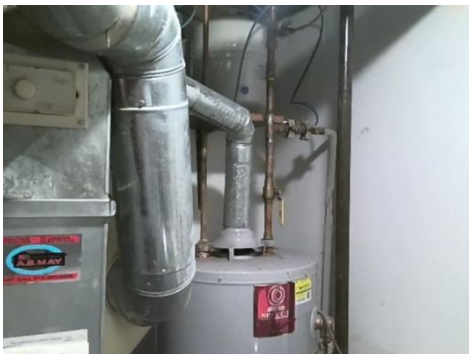
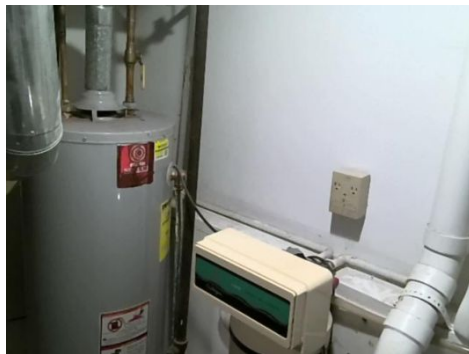
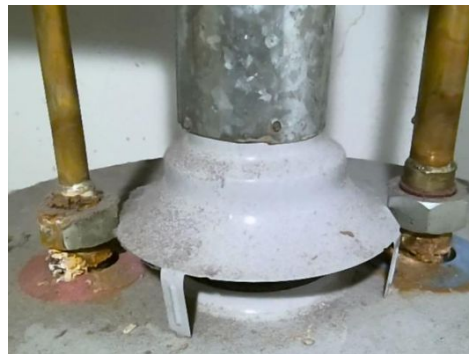
- Repair: Observed corroded piping at water heater connects. There may be a slow leak. Monitor and repair by licensed plumber if required.

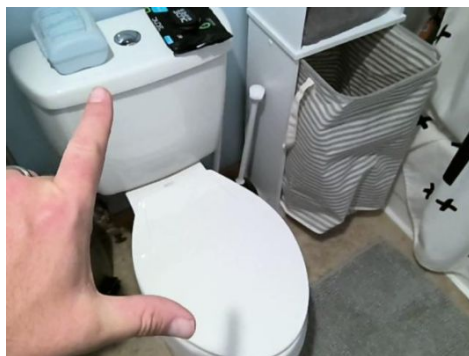
- Repair: The toilet in the main floor hall bath is loose. Recommend tightening.

loose

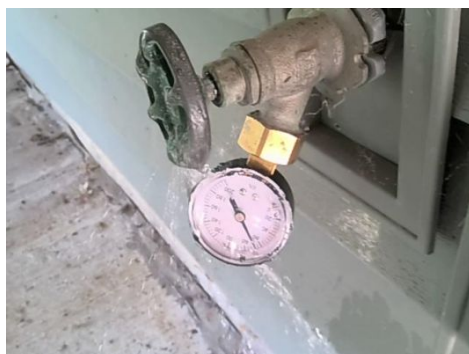
- Repair: Observed a leaking exterior faucet in back of the home. Recommend repairing the leak.

leaks from handle

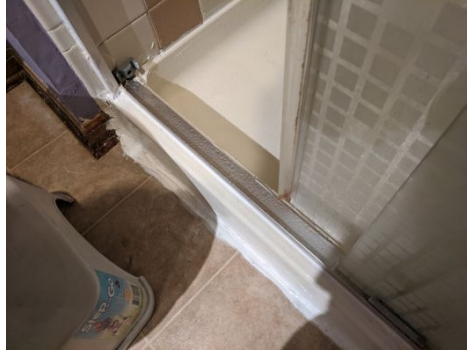
- Monitor/Repair: Noted microbial growth and excessive caulking in bathroom. Recommend monitor/remediate as needed.

microbial growth or mold near shower

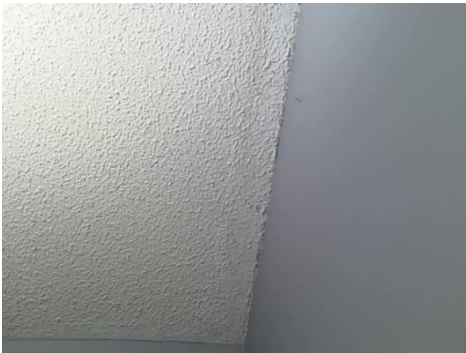
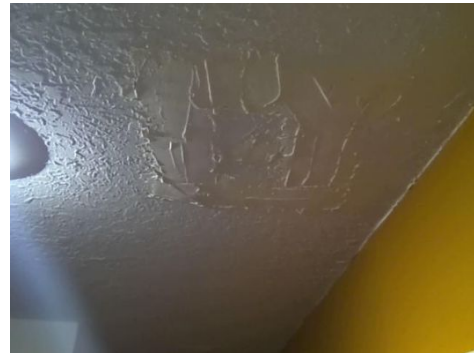
- Monitor: Noted a moisture stain in the entry ceiling . The stain was dry at the time of inspection and does not appear to have occurred recently. Recommend conferring with current owner for details and monitor for spread.

repair in basement ceiling

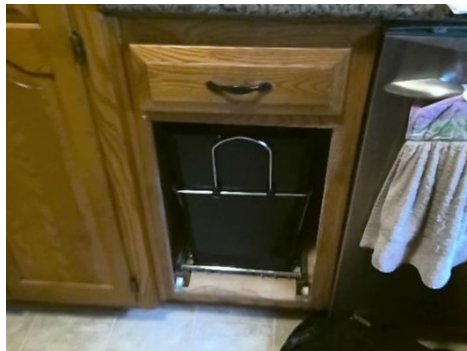
- Repair: Cabinet door was missing in the kitchen.

missing door

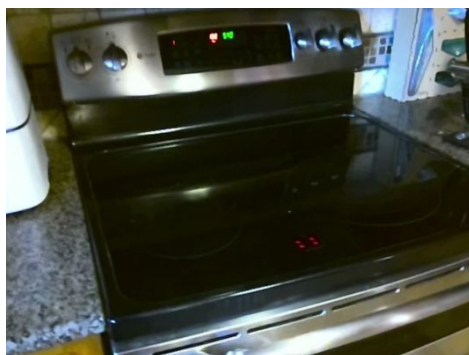
• Repair: Oven was not properly attached to the wall with anti tip brackets at time of inspection. Recommend repair.

not properly attached with anti tip brackets
